Erosion of Piston at Outer Ends of Piston Pin Hole

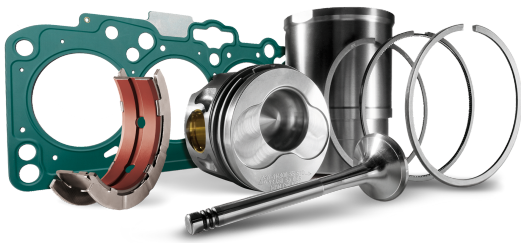
A hard object trapped in the space between the piston pin and the cylinder wall causes this type of damage. The rapid movement of the piston flings the object around in the confined space with sufficient violence as to erode the piston material. The effect is similar to prolonged shot blasting concentrated on to a small area.

However, the most common cause of this damage is a detached piece of a circlip or even whole circlip is. Over compression of a circlip will cause permanent deformation preventing it from springing back to its original shape. The clip will then not seat in its pin hole groove with sufficient force to retain it in operation. Over compression can also crack a circlip, which may fully fracture at some stage during service.

Tight small end connecting-rod bearings; out of line connecting rods or excessive crankshaft end float can all affect circlips by forcing the piston pin hard against one of the clips. A polished area on one end of a piston pin is a clear indication of such end thrust. In severe cases, the pin can hammer against a clip until it eventually dislodges. Piston erosion may then follow.

Many types of foreign objects cause this type of damage such as small nuts, screws and even ball bearings trapped in the piston pin area. Take care to assemble an engine in a clean condition and without contamination.
