## Diesel Piston Crown Erosion

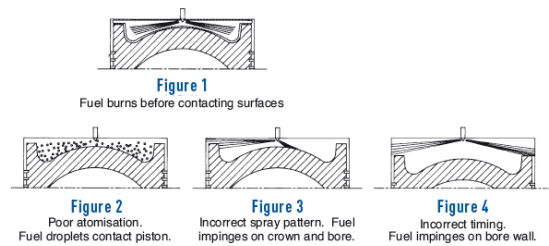
The first illustration shows a typical example of crown erosion. The periphery has been severely melted and burnt away and heavy carbon deposits are evident. Notice that a piece of steel is embedded in the exact centre of the crown. It is in fact the tip of the injector, which clearly under such conditions, has simply been squirting unatomised fuel onto the piston. Rare proof indeed of cause and effect.

When crown erosion is discovered in a diesel engine, make an immediate and thorough check of the whole fuel injection system. A piston alloy has not yet been invented that will resist fuel burning on its surface, and to blame the component's metallurgy, will simply delay identification of the true cause - a fuel injection system malfunction.

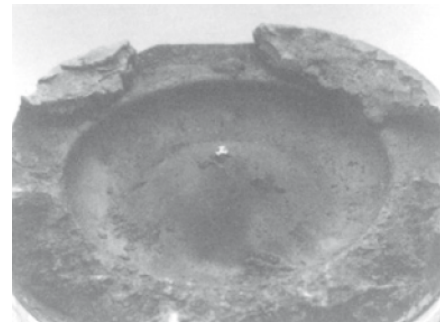
The second illustration similarly shows crown erosion due to a deformed spray pattern. Notice how the fuel, having burnt and eroded the crown area, has attached the ring lands and initiated a full skirt seizure.
