Cavitation Erosion of Wet Cylinder Liners

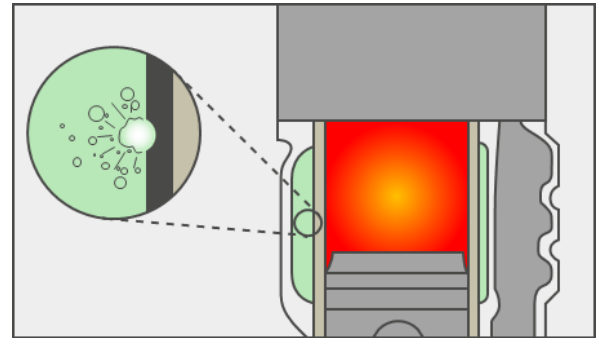
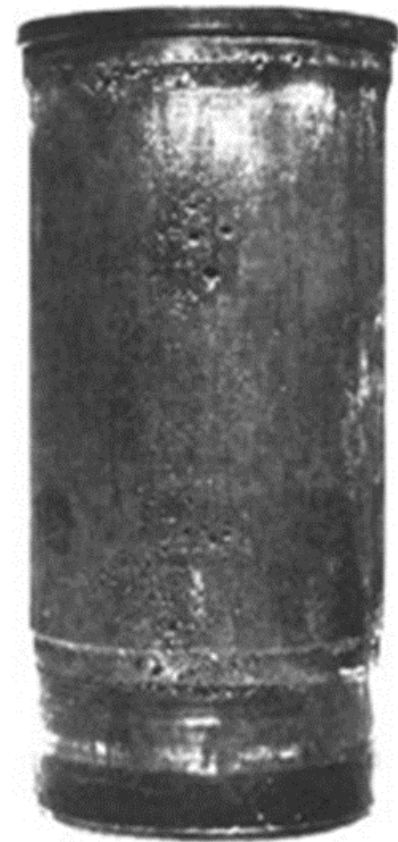
Pitting on the exterior of wet cylinder liners in diesel engines is normally a result of cavitation erosion.

High frequency vibrations during the combustion process causes very low pressure vapour bubbles to form in the coolant on the outside of the cylinder liner. As the vapour bubbles collapse or implode under continued vibration, pitting and erosion of the cylinder wall occurs.

Over time, repeated pitting in the same area can break through the liner wall. Coolant can then leak into the cylinder, contaminate the oil and can ultimately lead to complete engine failure.

The size, shape, distribution and rate of erosion of the pitted areas may vary between engines or even between cylinders within the same engine. The affected areas tend to be vertical bands in line with the thrust face of the piston and/or the area immediately above the liner sealing rings.

Cavitation resistant materials are now in use. Or it is possible to apply coatings can that prevent cavitation erosion. The best way to try and reduce or prevent cavitation erosion on liners which have no special material or coating is to:

- Strictly adhere to engine manufacturer's recommendations on coolant, coolant filter and SCA (Supplemental Coolant Additive) replacement.
- Ensure cylinder liner-to-block clearances are within specification - Incorrectly fitted liners can be a serious contributor to cavitation erosion.
- Ensure engine speed governing is operating correctly
