Piston Crown Contact

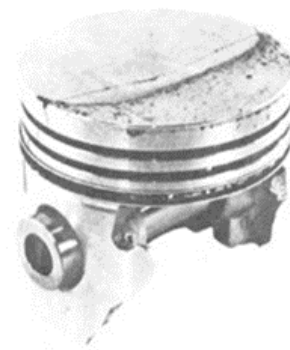
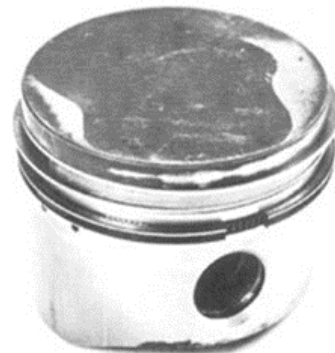
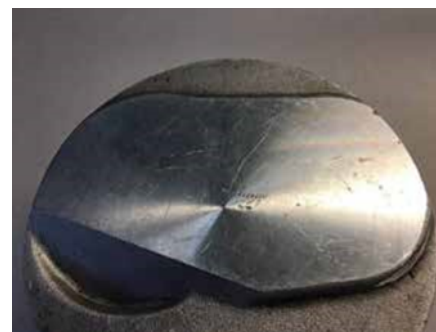
The effects of piston and cylinder head contact can range from a slight tapping sound to a shattered piston and possibly permanent damage to the cylinder block or head.

There will always be noise if the piston crown hits the head in operation, when the two parts make contact. There may also be a noticeable loss of power loss.

Stop the engine immediately if the symptoms occur when first starting the engine after a rebuild. Check the piston projection above the cylinder block face as there may have been remachining of block face without considering the height of the pistons. Or there may be inadvertent altering of the connecting rod centres during re-conditioning. Alternatively, there may be excessive crank journal throw.

If replacing engine components with performance parts, it is possible that oversized valves; alternate heads; and high lift and/or duration cams or rocker arms may also cause contact. Check these clearances with clay prior to running a freshly rebuilt engine.

If the symptoms occur after using the engine for some time, a condition inside the engine must have changed to permit extra piston travel. Examples of this are:

- Premature wear between piston pin and small end bush, and/ or piston.
- Damage to the lower half of the crankshaft journal bearing.
- Stretching, damage or fracturing of the bearing cap retaining bolts.

After finding the cause, take corrective action - this must include the replacement of affected pistons and connecting rods. Thoroughly inspect all related parts, especially the valves; repair and replace if necessary.
