## Piston Pin circlip failures

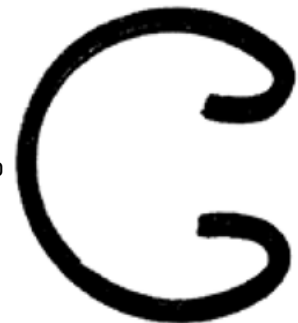
**Fig. 2**

**Fig. 2 - Rectangular**

Rectangular circlip

The most common cause of failure of all three is due to over-stress when fitting. Only compress a circlip just enough to slip into the piston pin boss. Never butt the ends, as this will overstress the circlip causing cracking or loss of tension.

Never twist a circlip when fitting. The circlip must enter the pin bore groove squarely and be under sufficient tension when fitted to prevent finger pressure rotation.

Install the circlip with the open end of the circlip towards the bottom of the piston. Never position the open end to either side of the vertical axis under any circumstance. During operation the reciprocating forces could compress the clip dislodging the ends to from the groove.

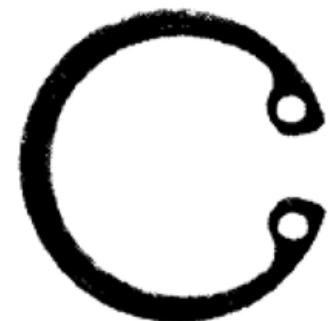
**Fig. 3**

**Fig. 3 - Seeger type circlip**

Seeger type circlip

Always use circlip pliers of the correct type, particularly when fitting the Seeger type of circlips. Most Seeger type circlips have metric sized holes for the pliers.
