## “Fixing Marks” on Phosphate Coated Pistons

“Fixing marks” / uncoated areas on the crowns of phosphate coated aluminium pistons are an effect of the phosphate coating process. They do not affect the piston operating properties, and the pistons are fully compliant with the acceptance specifications (Nüral TSIE-014-001).

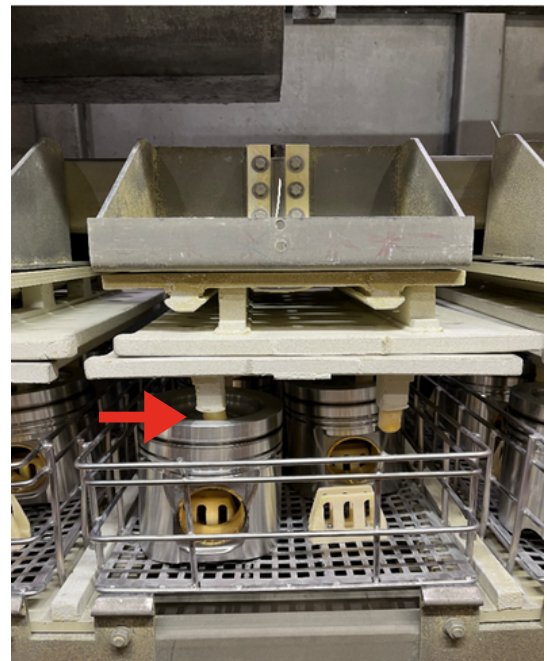
Picture 1:

Phosphate coating process: Pistons are clamped in baskets prior to immersion in a phosphate bath. Small marks occur where the clamp is in contact with the piston crown.

Phosphate coating prevents piston skirt scuffing during initial engine start-up; it has no functional effect on the piston crown. Phosphate coating on piston crown occurs when applying the coating to critical areas of the piston skirt. Clamping the piston in a basket as it rotates in the phosphate bath leaves small uncoated areas.

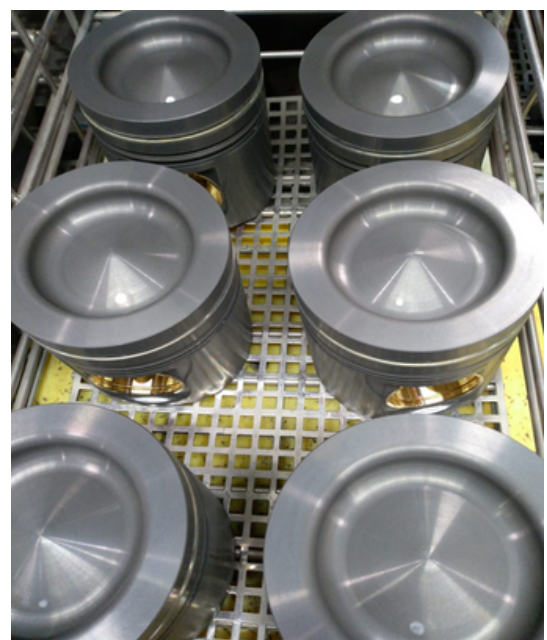
Picture 2:

Post-phosphate coating: Note the small bright circular uncoated “fixing marks” on the piston crowns.
