## Diesel Piston Crown Erosion

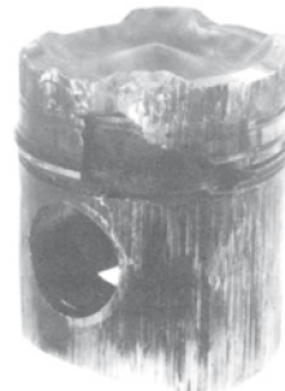
When this happens, the fuel burns in direct contact with the surfaces without the protective boundary layer being present. The rate of heat transfer from the combustion gases increases dramatically and temperatures rapidly exceed the melting point of piston alloys. Piston crown erosion inevitably follows.

The first illustration shows a typical example of crown erosion. The periphery has been severely melted and burnt away and heavy carbon deposits are evident. Notice that a piece of steel is embedded in the exact centre of the crown. It is in fact the tip of the injector, which clearly under such conditions, has simply been squirting unatomised fuel onto the piston. Rare proof indeed of cause and effect.

When crown erosion is discovered in a diesel engine, make an immediate and thorough check of the whole fuel injection system. A piston alloy has not yet been invented that will resist fuel burning on its surface, and to blame the component's metallurgy, will simply delay identification of the true cause - a fuel injection system malfunction.
