## Erosion of Piston at Outer Ends of Piston Pin Hole

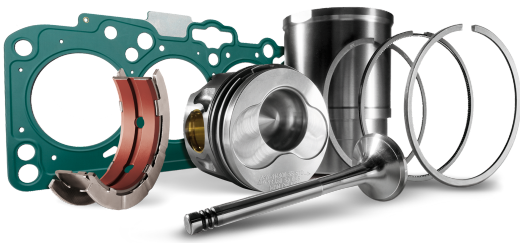
A hard object trapped in the space between the piston pin and the cylinder wall causes this type of damage. The rapid movement of the piston flings the object around in the confined space with sufficient violence as to erode the piston material. The effect is similar to prolonged shot blasting concentrated on to a small area.

However, the most common cause of this damage is a detached piece of a circlip or even whole circlip is. Over compression of a circlip will cause permanent deformation preventing it from springing back to its original shape. The clip will then not seat in its pin hole groove with sufficient force to retain it in operation. Over compression can also crack a circlip, which may fully fracture at some stage during service.

Tight small end connecting-rod bearings; out of line connecting rods or excessive crankshaft end float can all affect circlips by forcing the piston pin hard against one of the clips. A polished area on one end of a piston pin is a clear indication of such end thrust. In severe cases, the pin can hammer against a clip until it eventually dislodges. Piston erosion may then follow.

Many types of foreign objects cause this type of damage such as small nuts, screws and even ball bearings trapped in the piston pin area. Take care to assemble an engine in a clean condition and without contamination.
