Cylinder Liner Distortion

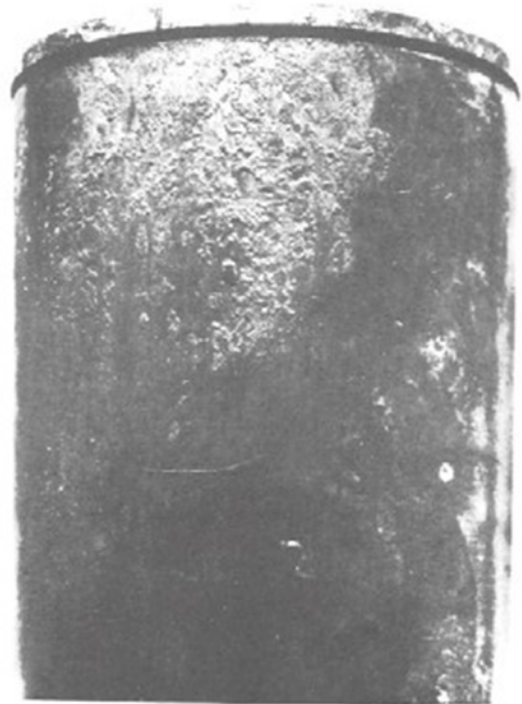
Distortion of the engine block can allow combustion gases to penetrate between the block and the outside of a dry liner. This allows carbon to form on the liner outer surface, which will restrict the normal heat flow. This in turn causes the liner to distort and reduce the piston's running clearance. Reduced running clearance and overheating of the cylinder wall will cause piston and ring scuffing and eventual seizure.

To reduce the possibility of cylinder liner distortion, thoroughly clean the cylinder block bores. Check there is no distortion and are to the correct size specifications. Ideally, complete this inspection with all block fittings attached and correctly tightened. Ensure all water passages are clear and free of scale. Any restriction of coolant flow can lead to cylinder block distortion.
