Goetze Anti-Polish Ring (Fire Ring)

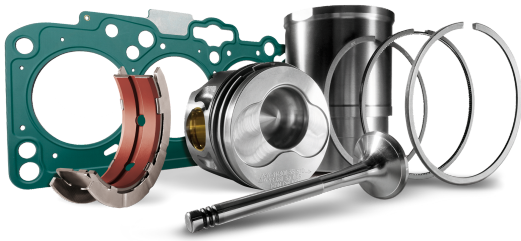
Commercial Vehicle engine manufacturers are adopting the solution of introducing an Anti-Polish Ring (Fire Ring) into the cylinder liner wall adjacent to the piston top land when the piston reaches Top Dead Centre (TDC).

The inner diameter of the fire ring is slightly smaller than that of the cylinder bore, and the piston top land is machined slightly smaller to compensate for the protrusion of the Anti-Polish Ring into the cylinder bore.

As the piston reaches TDC any carbon deposits forming on the top land will be scraped away thus preventing any polishing of the bore as the piston travels down the cylinder bore.

The Anti-Polish Ring should always be fitted when supplied with a cylinder liner designed to accommodate one as failure to fit will result in severe loss of compression and engine power.
